PAST, PRESENT AND FUTURE:
STRUCTURAL SAFETY FROM AN INTERNATIONAL PERSPECTIVE

14th March 2019

Dirk Rinze Visser, MSc CEng RC

CONTENTS

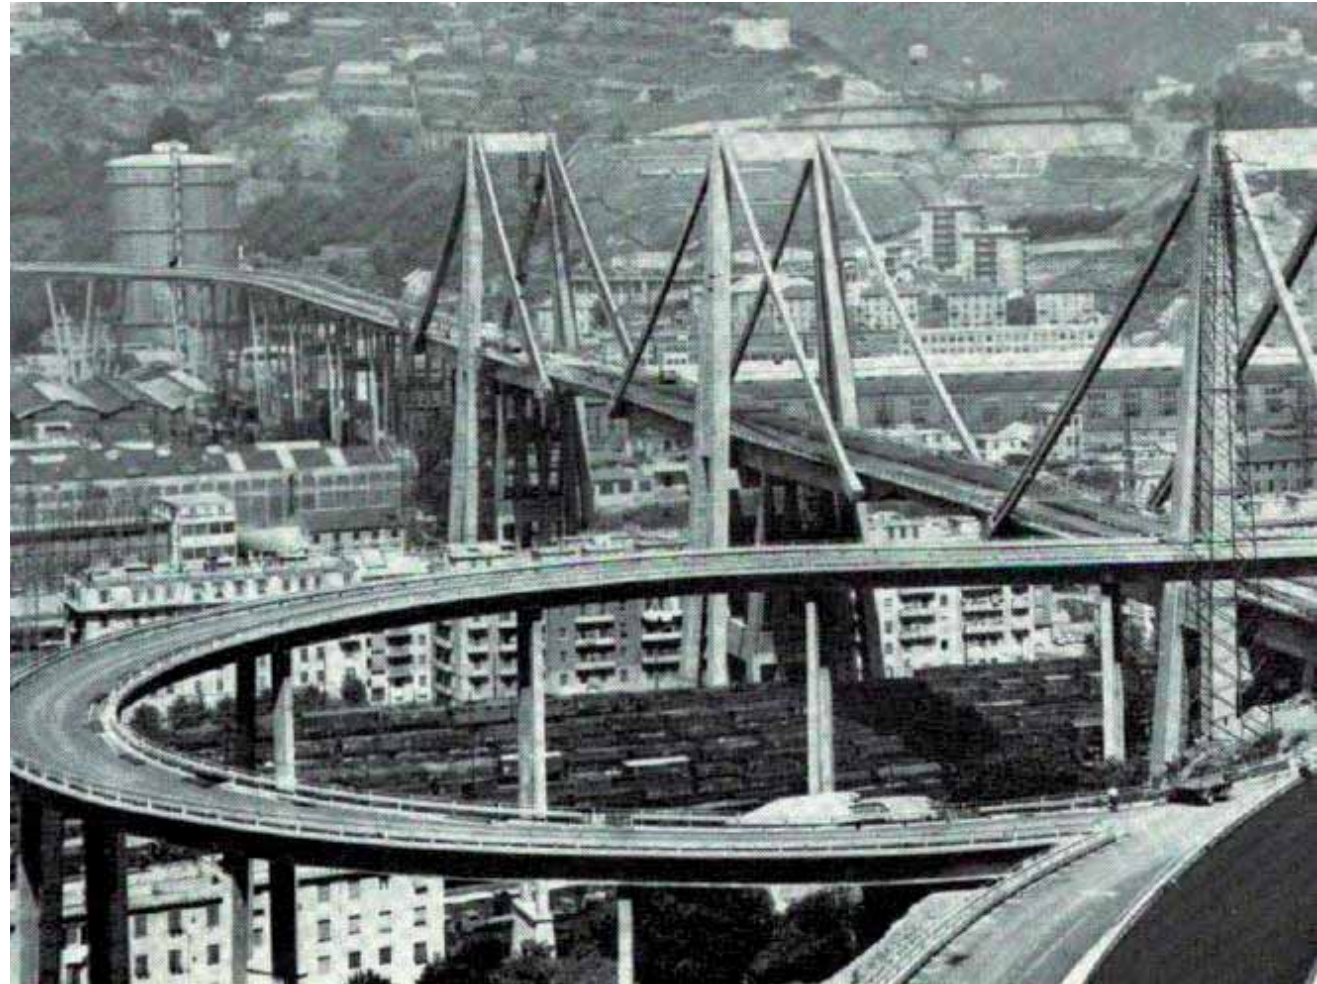
MORANDI BRIDGE BACKGROUND

- Genoa, Italy
- Cabled stayed bridge
- Designed by Riccardo Morandi
- Completed in 1967
- Vital link in Italy's road network

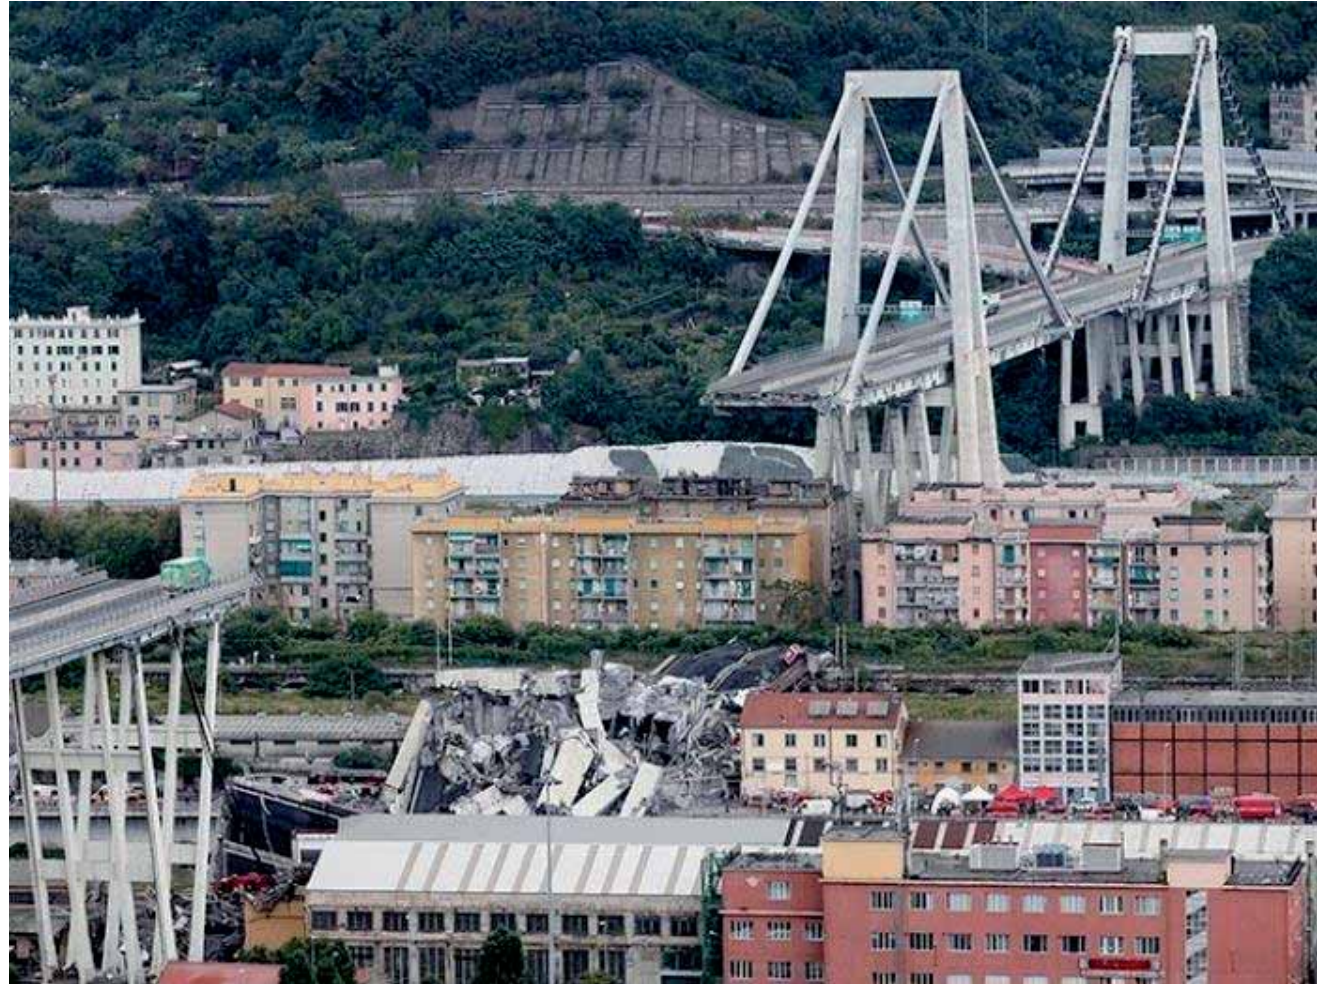
MORANDI BRIDGE STRUCTURAL FAILURE

- Lack of redundancy in the structural design
- Adverse weather conditions
- Increase in traffic demand
- Age of construction
- General deterioration of structural system
- Presence of corroded stays

Progressive collapse took only 4-5 seconds according to CCTV

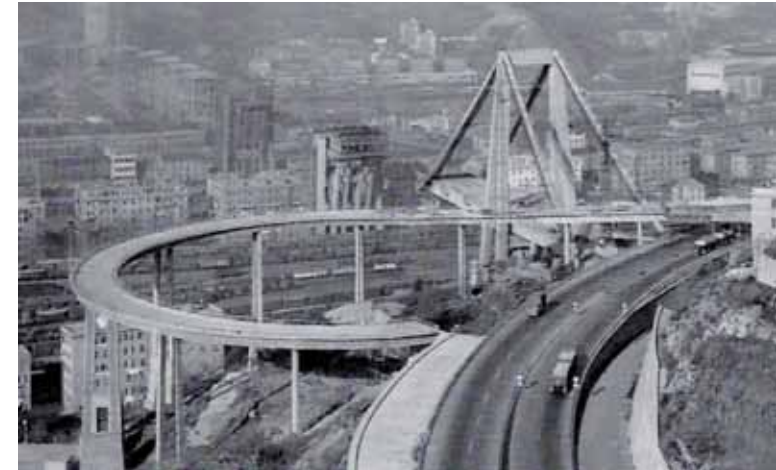
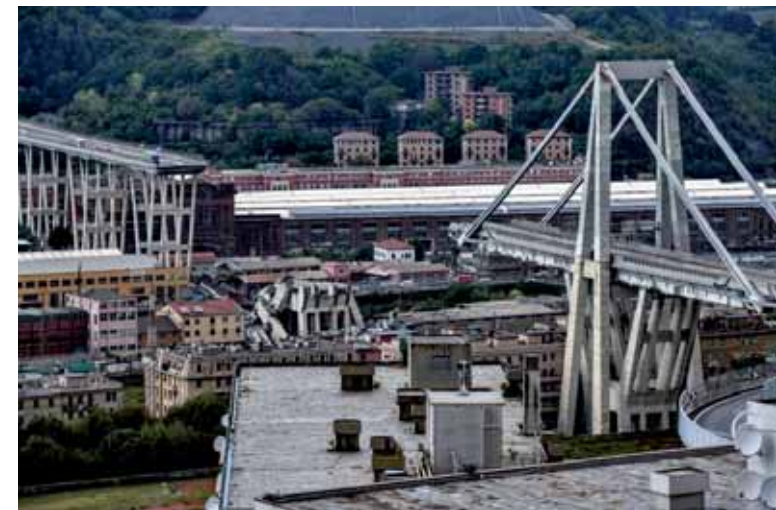
MORANDI BRIDGE LACK OF REDUNDANCY

- Very simple stay arrangements, using prestressed concrete stays rather than the steel cables already in wide use at the time
- Need for rigorous inspection and maintenance (difficult by concrete encasement)
- Admiration by engineers and architects for its simplicity clear expression of the flow of forces
- Modern cable stay structures use multiple stay cables and are typically designed for the accidental loss of one or more stays

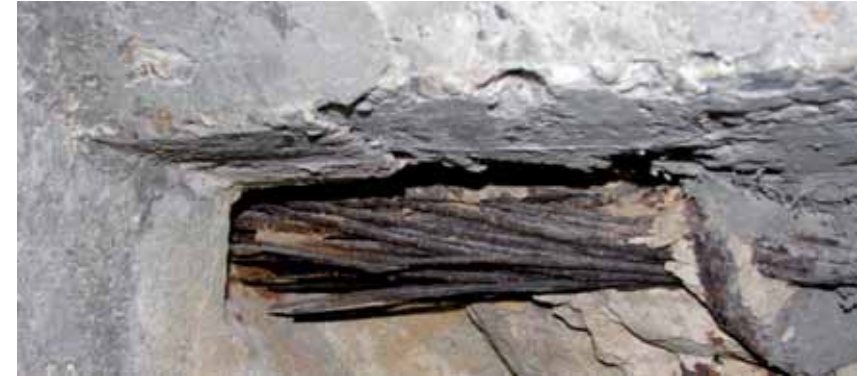
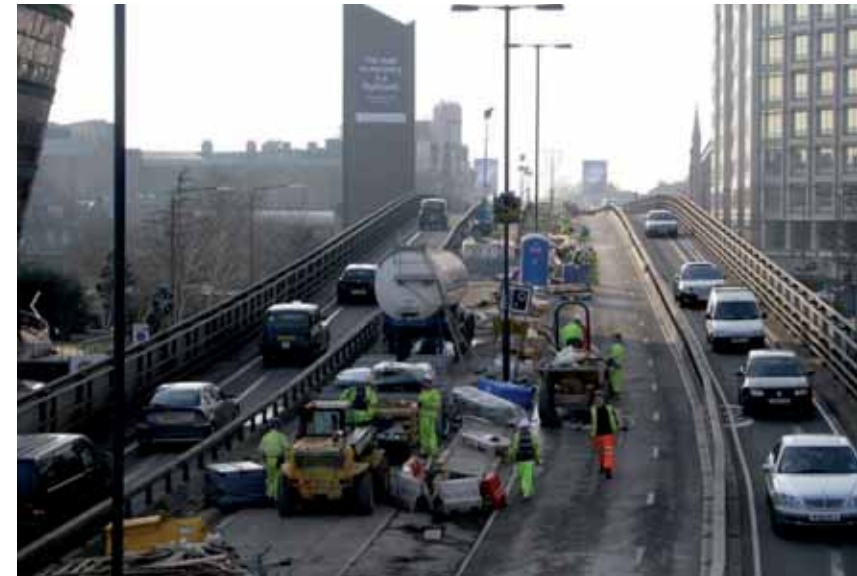
HAMMERSMITH FLYOVER STRENGTHENING

- Two distinct and separate phases of work to strengthen the flyover:
 - Pre-2012 Olympic Games strengthening, to enable full traffic load
 - Restore the capacity of Hammersmith Flyover for at least the next 60 years without requiring major maintenance
- The works could continue throughout day and night within the lane restrictions without having any additional impact on traffic

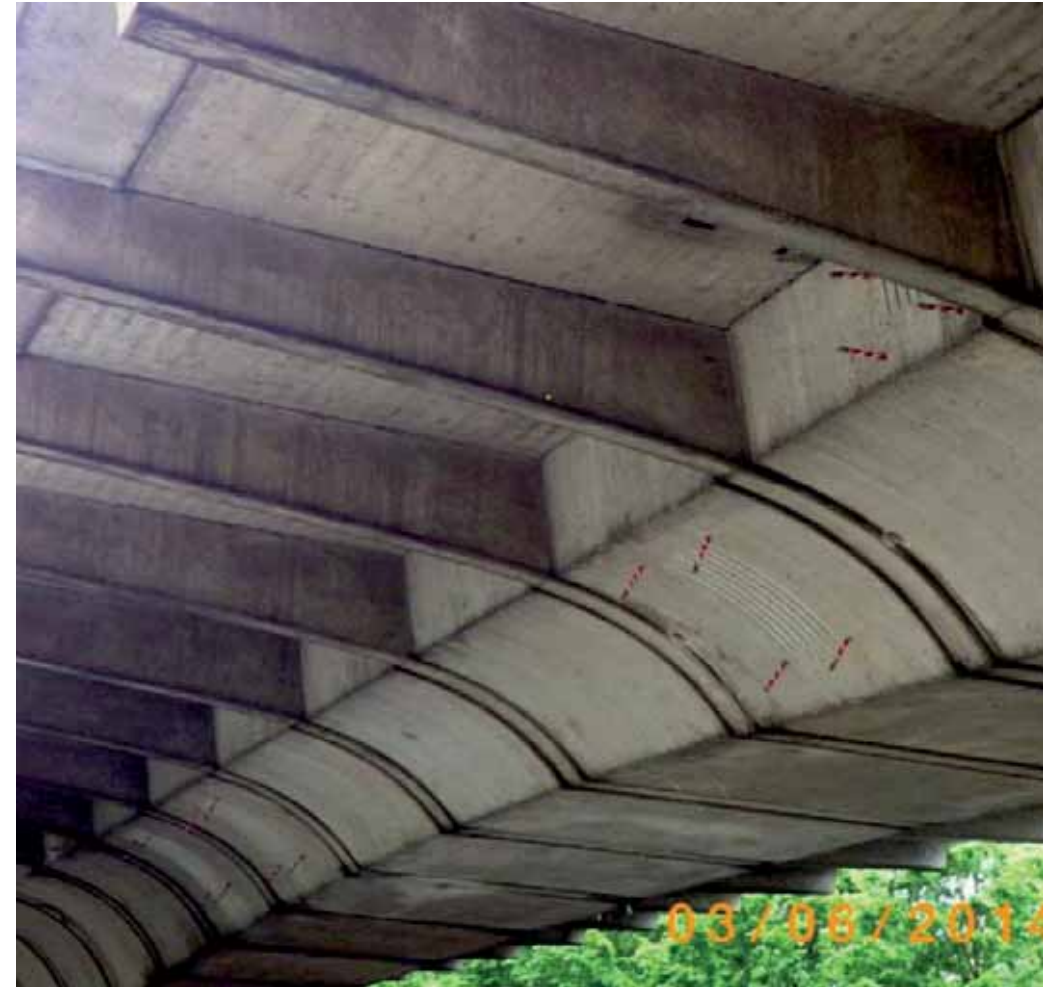
HAMMERSMITH FLYOVER NEW PRESTRESSING SYSTEM

- Location of the new tendons; a critical issue as the optimum location was already utilised
- 3D modelling was used extensively both in the design and construction methodology for clash detection between the new elements and the existing structure
- 3D model helped inform, verify and challenge design assumptions and test construction scenarios
- Innovative solution: combination of long deviated tendons inside the box and short straight tendons largely outside were used

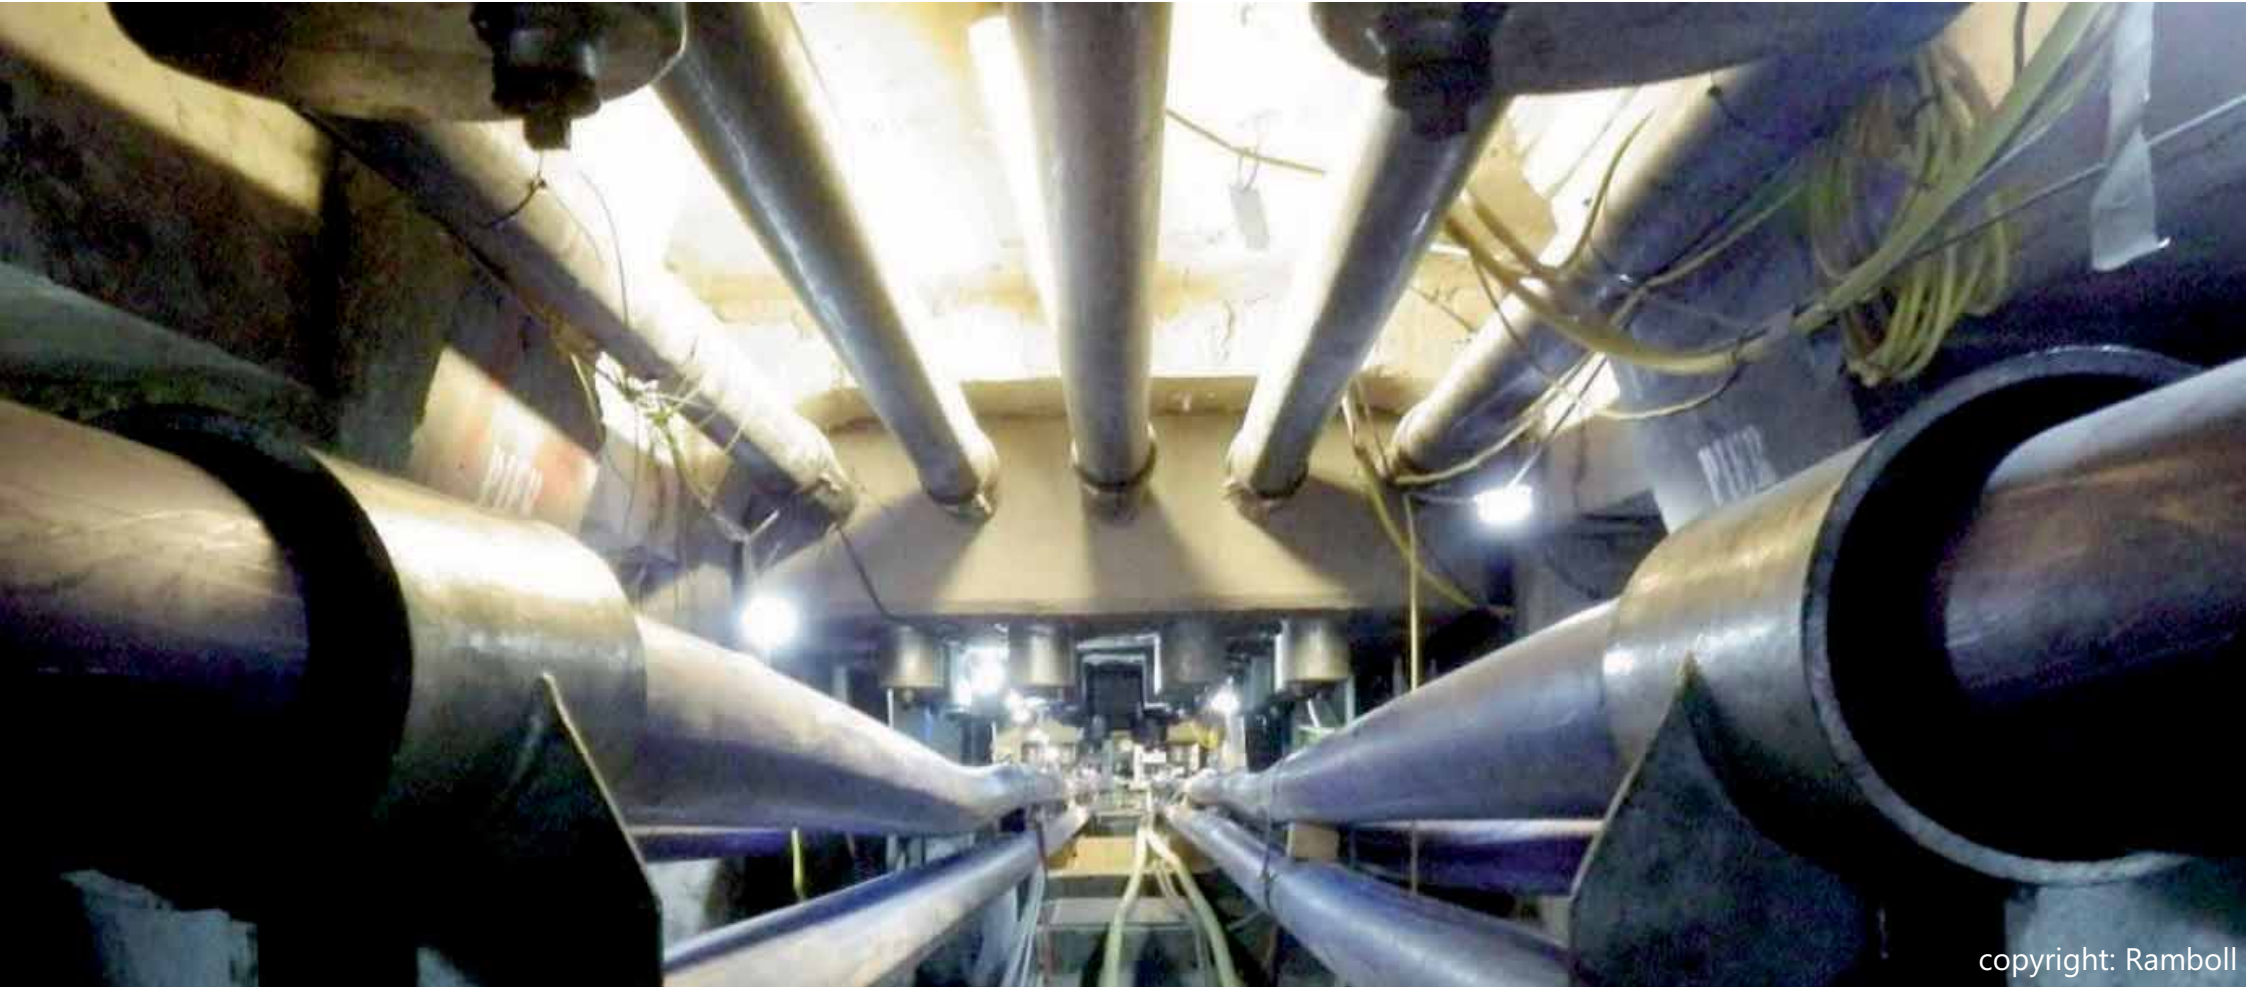
HAMMERSMITH FLYOVER

NEW PRESTRESSING SYSTEM: ANCHORAGE DESIGN

- Straight tendons are hot-dip galvanised and protected by polyethylene sheaths, and anchored with innovative ultra-high performance fibre reinforced concrete anchors (UHPFRC up to 170MPa)
- 192 innovative (bespoke) anchors, up to 1500mm x 900mm
- Minimise the additional stresses on the structure, but strengthening backing slabs was needed
- Long deviated tendons, up to 300m in length, are anchored in larger more conventional anchors

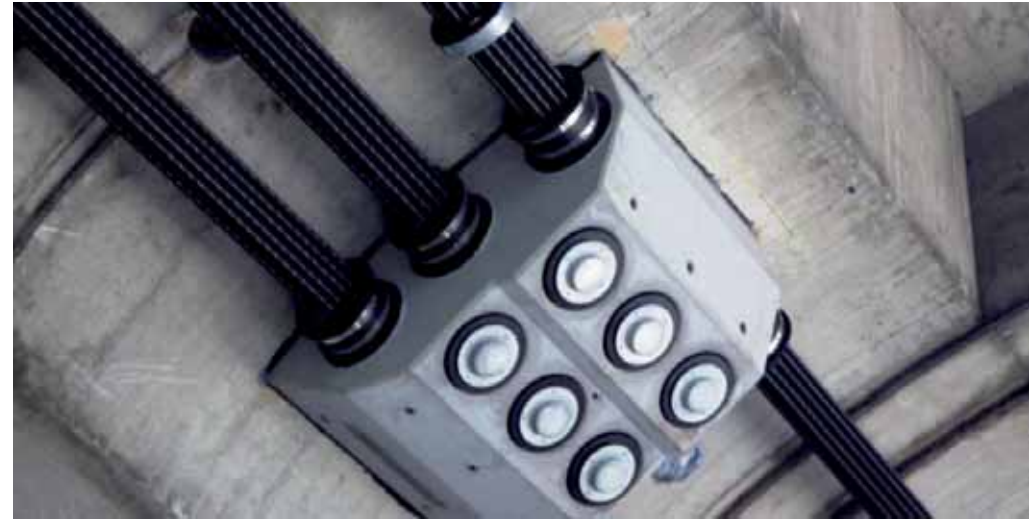
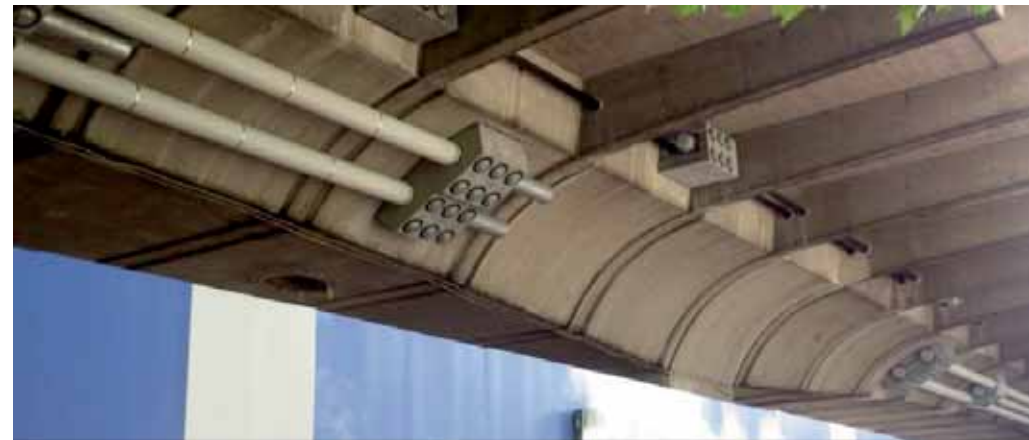
HAMMERSMITH FLYOVER NEW PRESTRESSING SYSTEM: UHPFRC

- Use of UHPFRC has raised the bar in the concrete repair industry
- UHPFRC has not been used in this application before in UK and design is not covered by the Eurocodes
- Successful testing by Freyssinet validated the performance under service loads, thus confirming the ability of the blisters to transfer the prestressing anchorage forces
- UHPFRC benefitted the new prestressing system with 50% reduction in size, only minimal conventional reinforcement required and lower weight of the concrete anchorage which enabled the minimum headroom clearance to be maintained for road users passing beneath the flyover
- Use of efficient off site precast manufacturing and testing techniques ensured consistency of product and full quality compliance

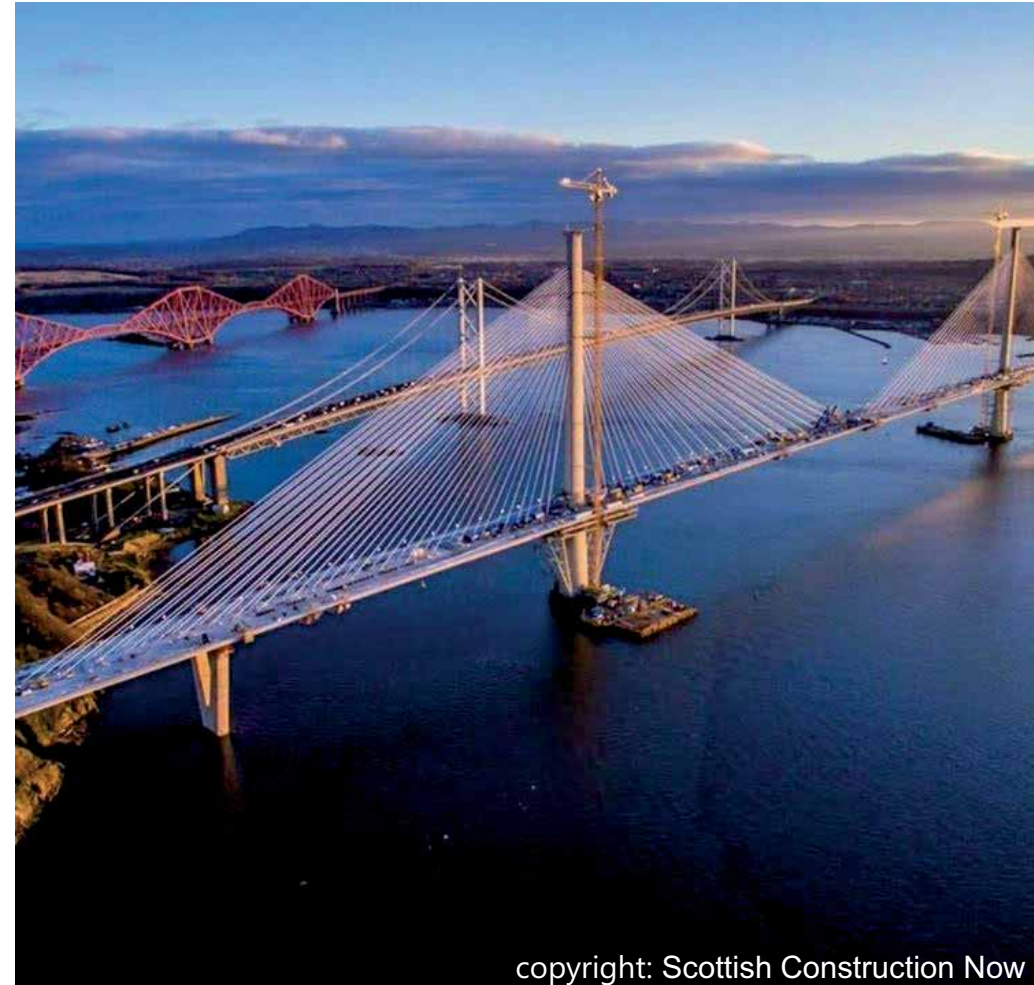
BRIDGES OVER THE FORTH BACKGROUND

- Three world class bridges spanning the Firth of Forth outside Edinburgh in Scotland.
- Each built in a different century and demonstrates a different bridge engineering solution, representative of the age:
 - Forth Bridge, cantilever, 1890
 - Forth Road Bridge, suspension, 1964
 - Queensferry Crossing, cable stayed, 2017
- Bridges present an evolution in the attitude towards long term maintenance at the design stage of bridges

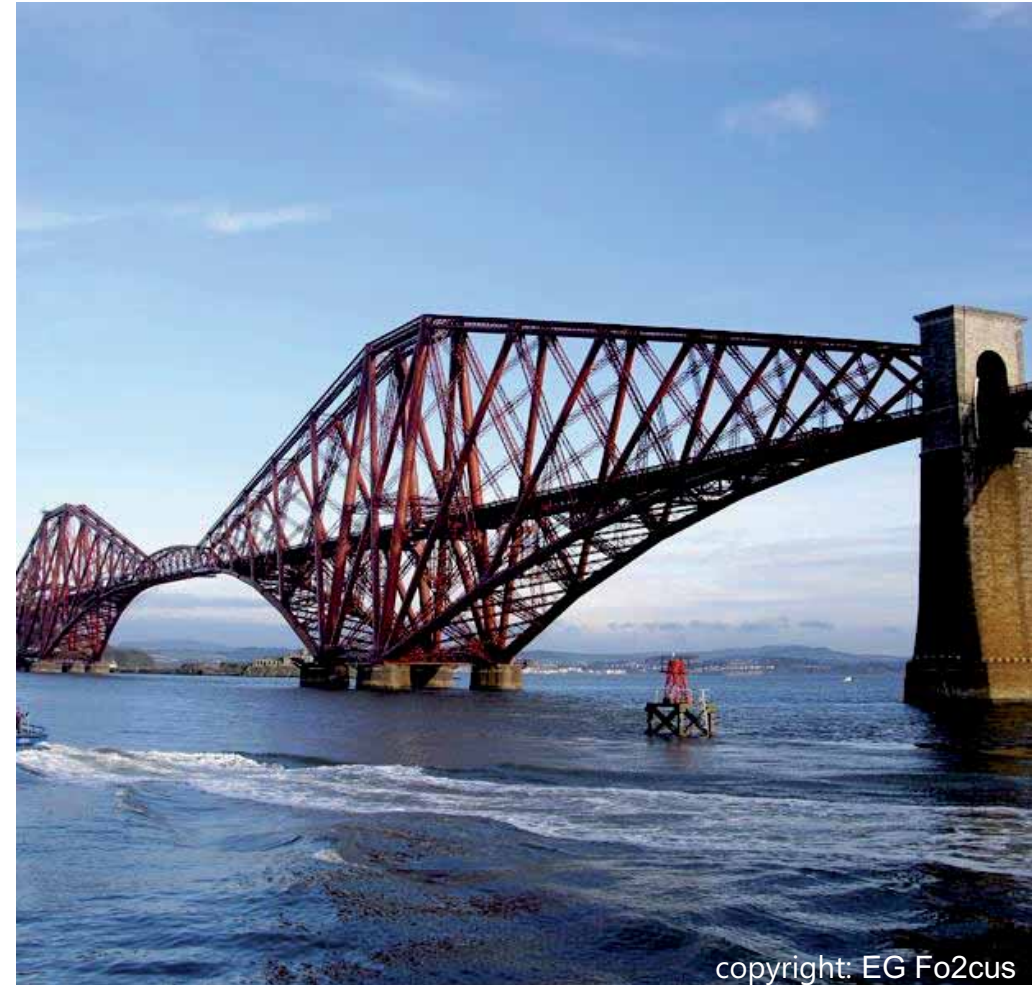
THE FORTH BRIDGE

- Steel cantilever rail bridge constructed in 1890
- First major steel structure in the UK
- Originally designed as a suspension bridge, but withdrawn after the Tay Bridge disaster in 1879
- Very robust and oversized (“build and forget”)
- Principal maintenance issue is repainting of the large surface area of steelwork
 - Permanent maintenance team of painters
 - New 3-coat paint system

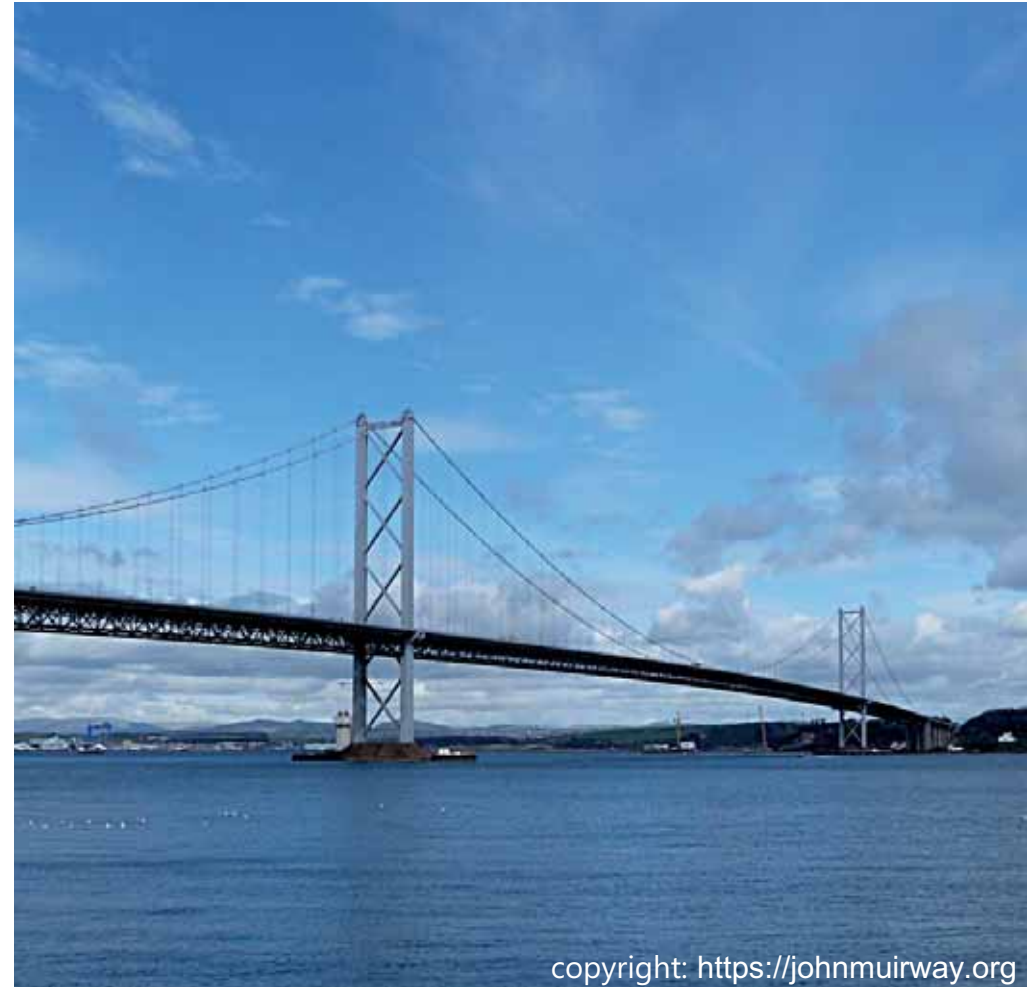
BRIDGES OVER THE FORTH

FORTH ROAD BRIDGE: CORROSION OF MAIN CABLES (I)

- Two main cables are each made up of ~12,000 high tensile galvanised wires, 5 mm in diameter
- Painted in red lead paste and wrapped circumferentially with a galvanised wrapping wire
- Exterior of the wrapping wire was painted and finally a protective membrane was wrapped around the cables
- No way to inspect the main bridge wires without taking the wrapping wire off and opening up the cables to allow an inspection
- **In this respect it bears similarity to the Morandi Bridge in Genoa**

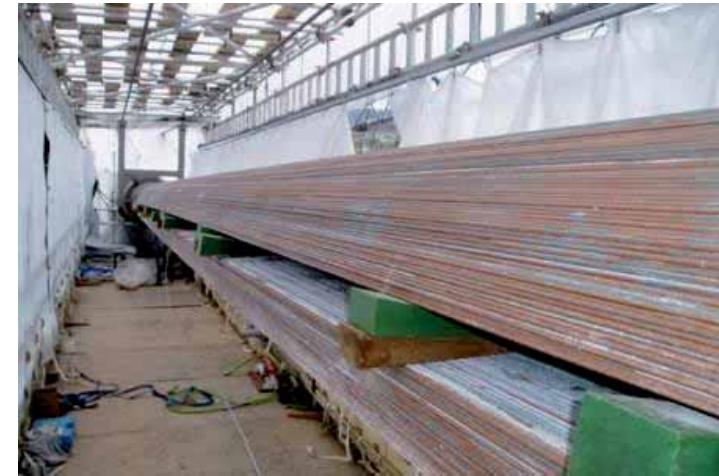
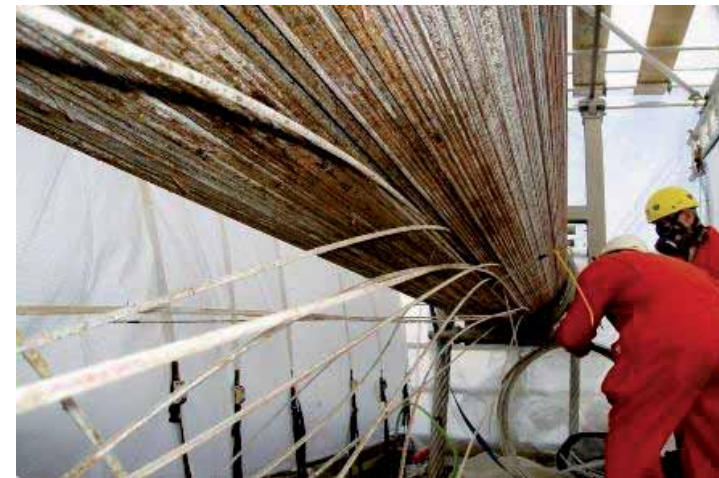
BRIDGES OVER THE FORTH

FORTH ROAD BRIDGE: CORROSION OF MAIN CABLES (II)

- First suspension bridge in Europe to have its main cables opened up
- No exterior signs of deterioration
- Concern that corrosion might be present inside – as had recently been discovered in the cables of older American long span suspension bridges
- Unwrapping cable at selected locations and driving hardwood wedges into the bundle of wires
- Specially designed access gantries were used that could crawl up and down the cable independently, eliminating the need for traffic restrictions while work was in progress
- 8-10% of the cable's strength had already been lost as a result of corrosion – despite the cable at that time being just 40 years old
- If deterioration could not be halted, the cable could lose 13% of its strength by 2014, and possible full closure of the bridge by 2020 (achieving less than half its design life)

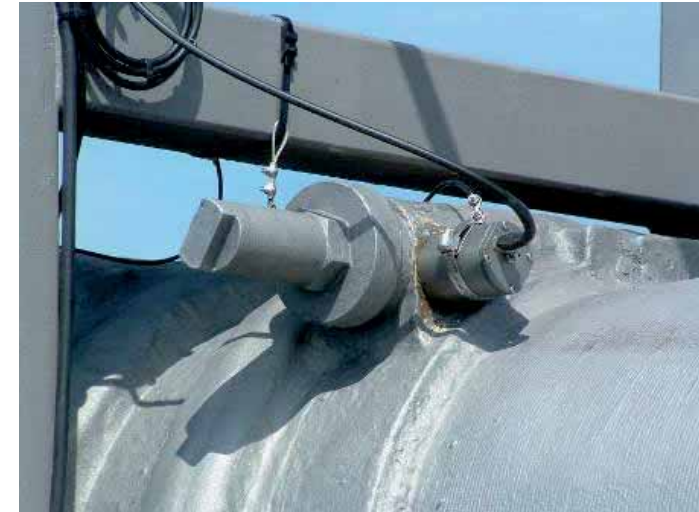
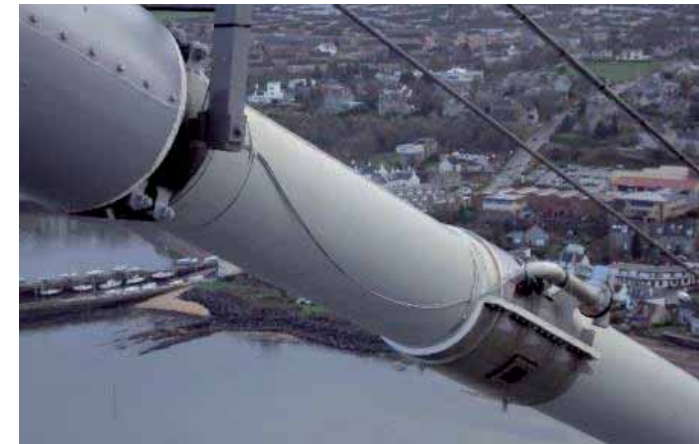
BRIDGES OVER THE FORTH

FORTH ROAD BRIDGE: REMEDIAL ACTION

- Acoustic monitoring system (2006) to monitor future wire breaks
- Dehumidification system (2009): pumping dried air into the cables at low pressure, having first wrapped it in an airtight neoprene membrane with the aim of reducing the relative humidity to below 40% where corrosion cannot occur
- No further loss of strength has occurred since 2009
- Bridge is now expected to achieve its original 120 year design life
- Due to the uncertainty and imminent risk of closure, in 2007 it was decided to construct a new road bridge

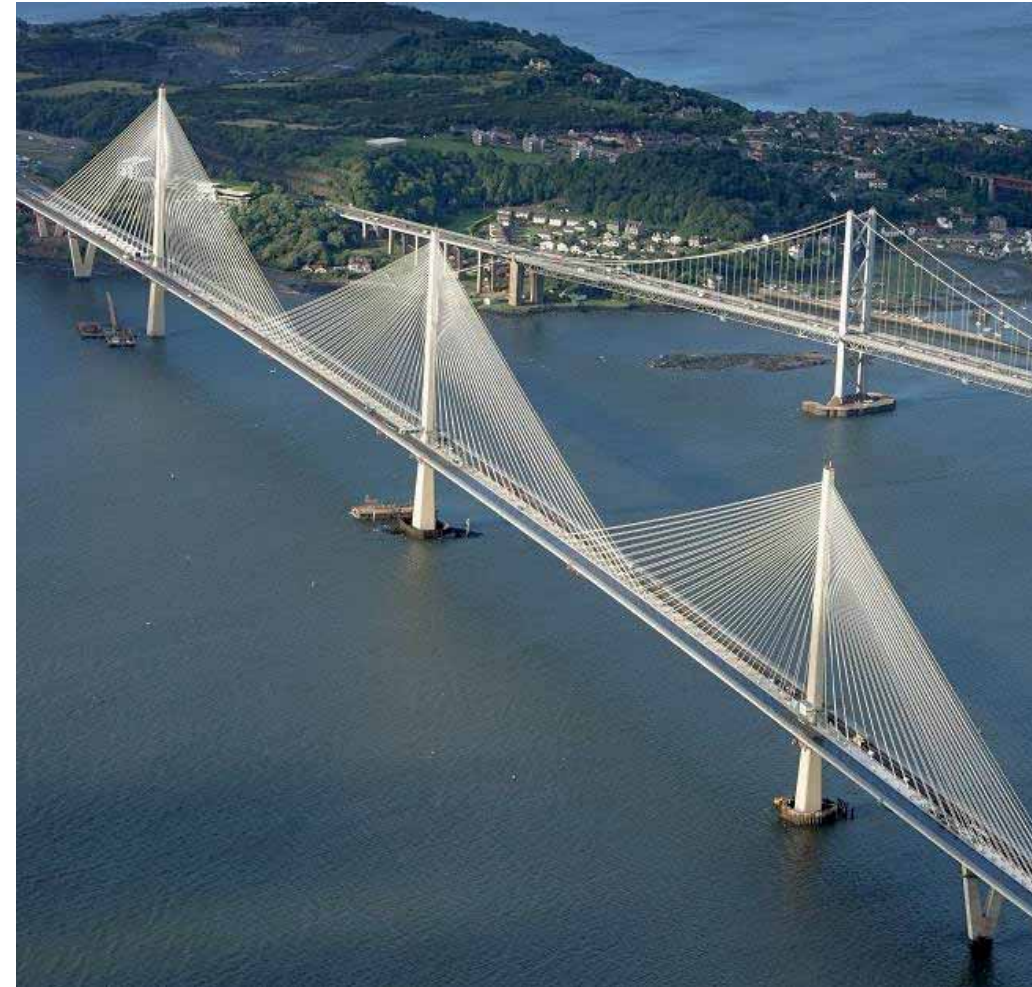
BRIDGES OVER THE FORTH QUEENSFERRY CROSSING

- Cable stayed road bridge opened in 2017
- 2.7km structure is the longest three-tower, cable-stayed bridge in the world
- By far the largest to feature cables which cross mid-span
- Innovative design provides extra strength and stiffness, allowing the towers and the deck to be more slender and elegant

- Evolution in the attitude towards long term maintenance in bridge design
- Integrate whole life maintenance
 - Monitor condition and behaviour
 - facilitate the repair and replacement of components, if required
- Builds on experience from around the world and marks departure from “build and forget”
- Provisions to facilitate inspection and maintenance have been built into the design
 - strands can be individually replaced without the need to restrict traffic

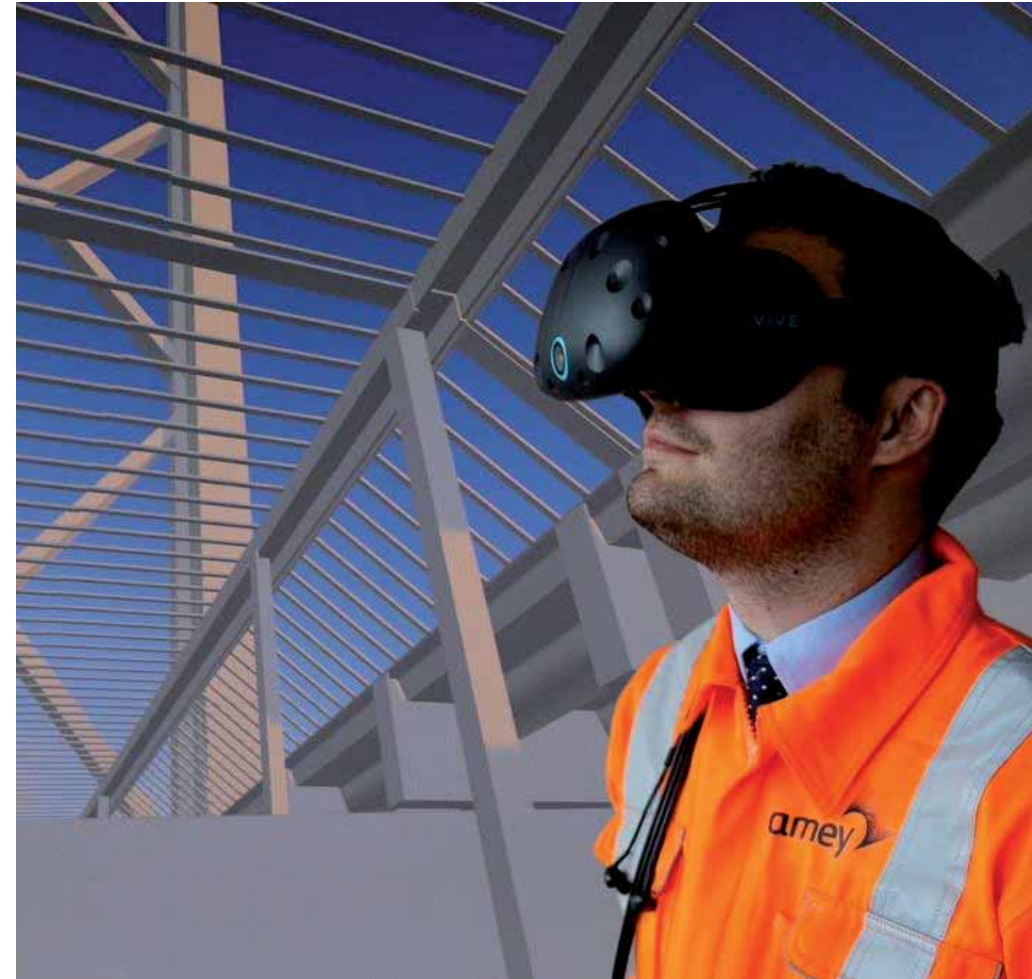
QUEENSFERRY CROSSING: TECHNOLOGY AIDING INSPECTION WORK

- Virtual reality (VR) model of the bridge has been created and the maintainers are trialling the use of VR by engineers to view 360° camera footage captured by drones on site
- Advanced monitoring system and inspection technology has been deployed on the Forth Road Bridge as well, improving the structural health of both bridges
- Both bridges are brought into an integrated “managed crossing scheme” safeguarding the future of this vital road link for the UK
- Use of such technology in bridge inspections is still new in the UK

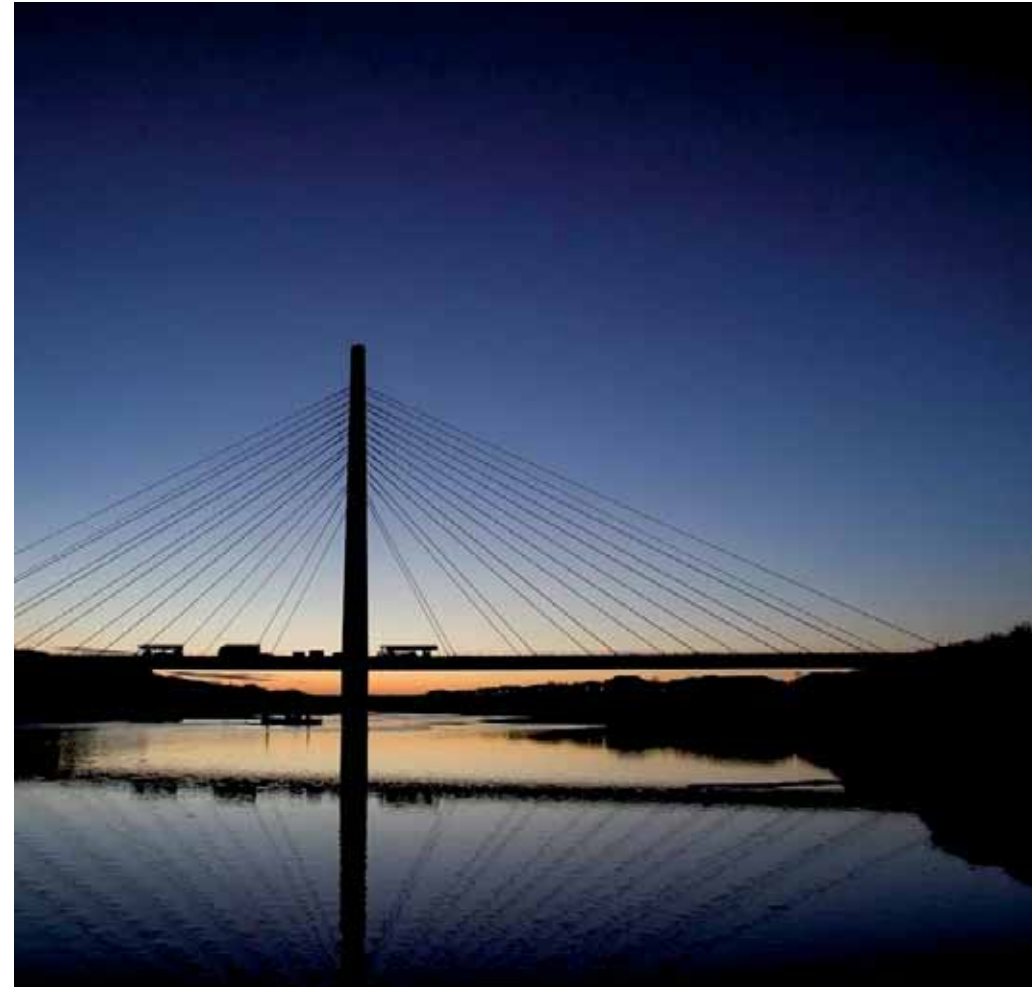
NORTHERN SPIRE

MAKING THE VISION VIABLE WITHOUT DISREGARDING MAINTENANCE

- Catered for future access requirements of a principal inspection
- Adjustable and fixed end anchors are located at deck level and within the pylon
- Access has been fully integrated into the principle structure
- All inspection and testing equipment are catered for in the design and in the detailing of the bridge
- Platforms, ladders, guardrails, internal lighting and power sources have been provided
- Connection points have been provided on the steel pylon for installation of a proprietary scaffolding system for access to the external pylon
- The inner face of the pylon is to be accessed by abseiling
