STRUCTURAL SAFETY FROM AN INTERNATIONAL PERSPECTIVE

PAST, PRESENT AND FUTURE

Dirk Rinze Visser MSc CEng RC and Thomas Eckhart MEng CEng MICE,
both working at BuroHappold Engineering in London, United Kingdom

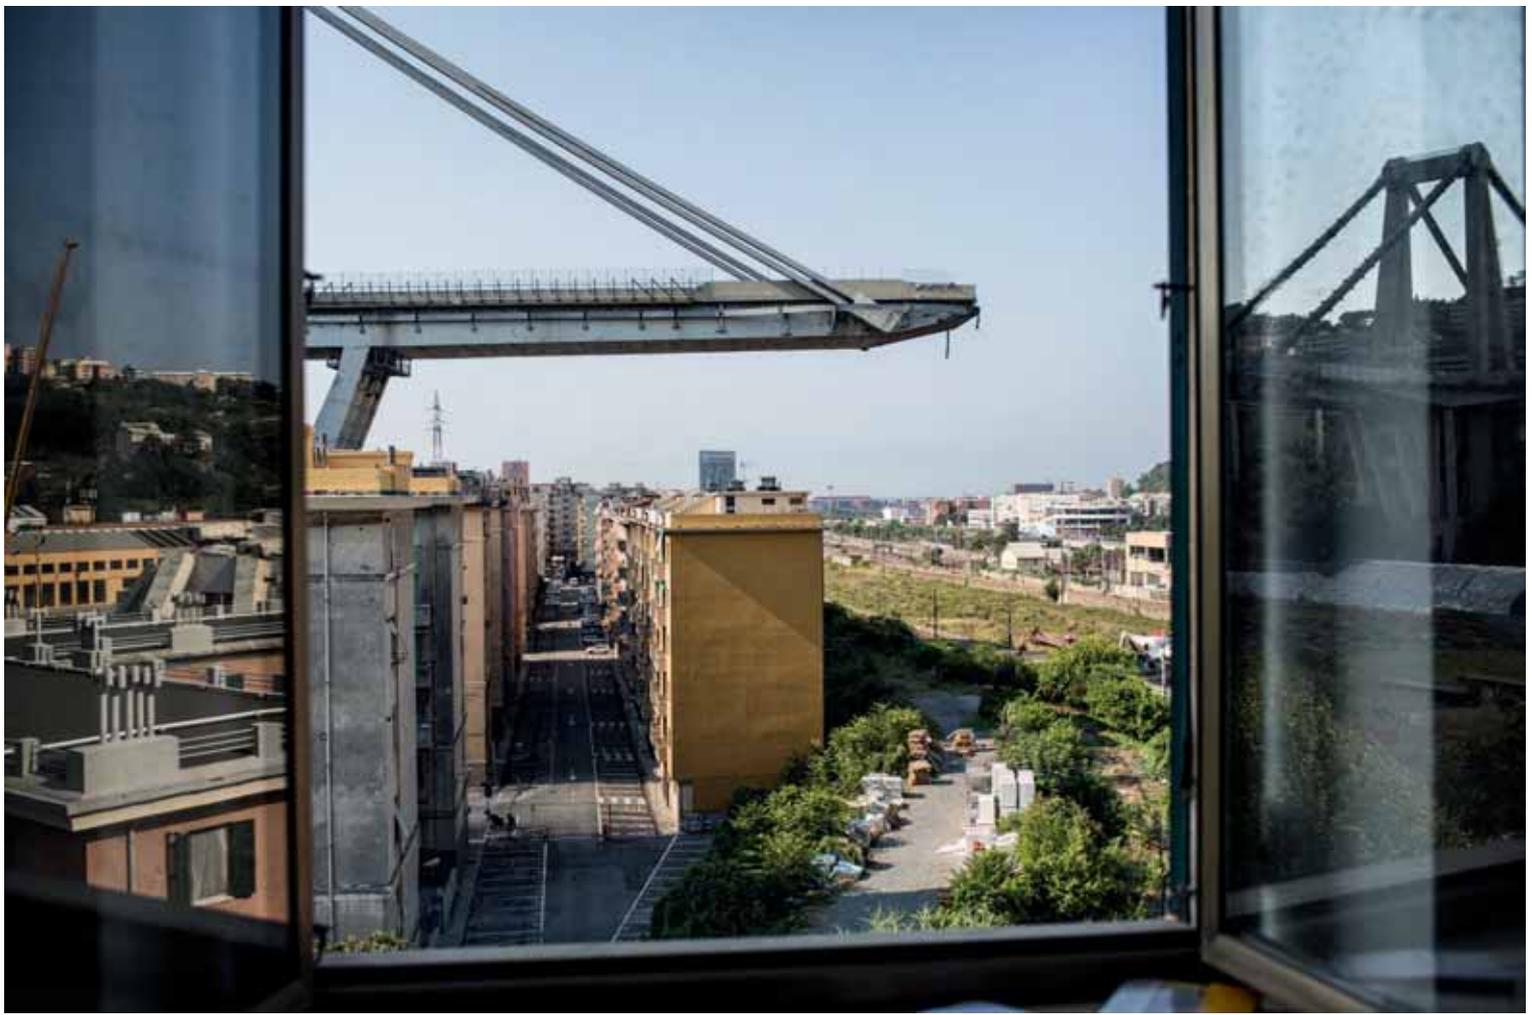
Collapsed Morandi Bridge in Genoa, Italy (image: New York Times)

The Polcevera Viaduct, otherwise known as the Morandi Bridge, named after its designer Riccardo Morandi, is a cable-stayed bridge completed in 1967. During a thunderstorm on the 14 August 2018, the bridge partially collapsed, killing 43 people, and leaving a huge gap in both the local community and Italy's strategic road network.

First of all, it must be stressed that the investigation into the cause of the collapse is ongoing and until the investigation is complete, it is only possible to speculate. Some possible reasons of the collapse

(adverse weather, increase in traffic demand and age of the construction) have been identified immediately after the tragic event, but maintenance issues, general deterioration of the structural system and presence of corroded stays have also been highlighted by experts.

Morandi's bridge has been much admired by engineers and architects for its simplicity and clear expression of the load paths, but it subsequently created a lack of redundancy in the design. A second load path – the remaining stays to resist the additional load transfer from of a sudden failure of a stay – is not included in the design (see page 27).

The apparent lack of redundancy does place extra emphasis on the need for rigorous inspection and maintenance. However, inspection of the critical stay cables was made difficult by Morandi's use of prestressed concrete encasement.

In the 1990s the eastern stays of the eastern most pier were strengthened after detected corrosion, likely due to marine chlorides (Mediterranean Sea) and from the application of road de-icing salt. Additional external steel cables were installed on the exterior of these concrete stays. However similar work was not carried out on the other two piers, including the one that collapsed.

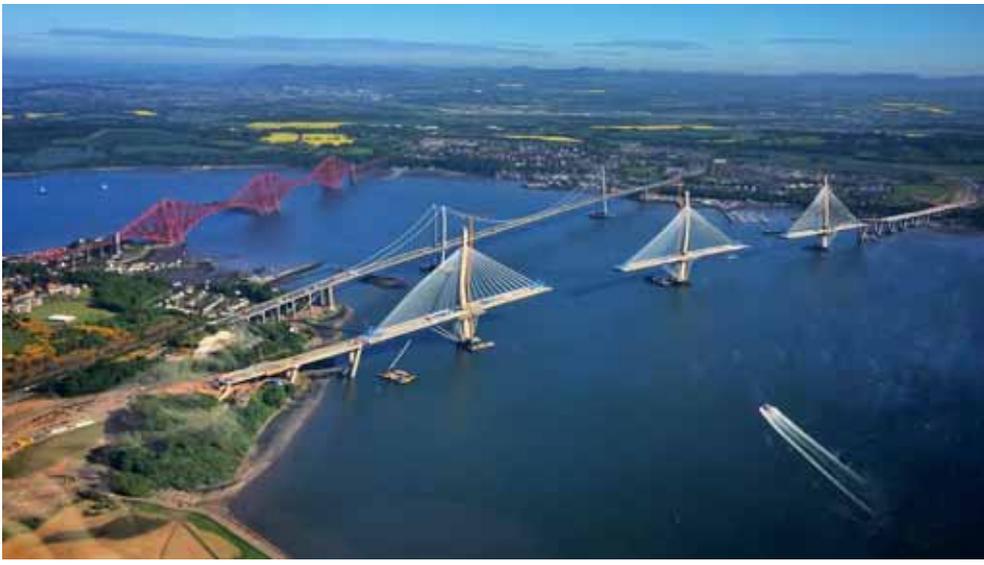
The three bridges over the Firth of Forth (image: Scottish Construction Now)

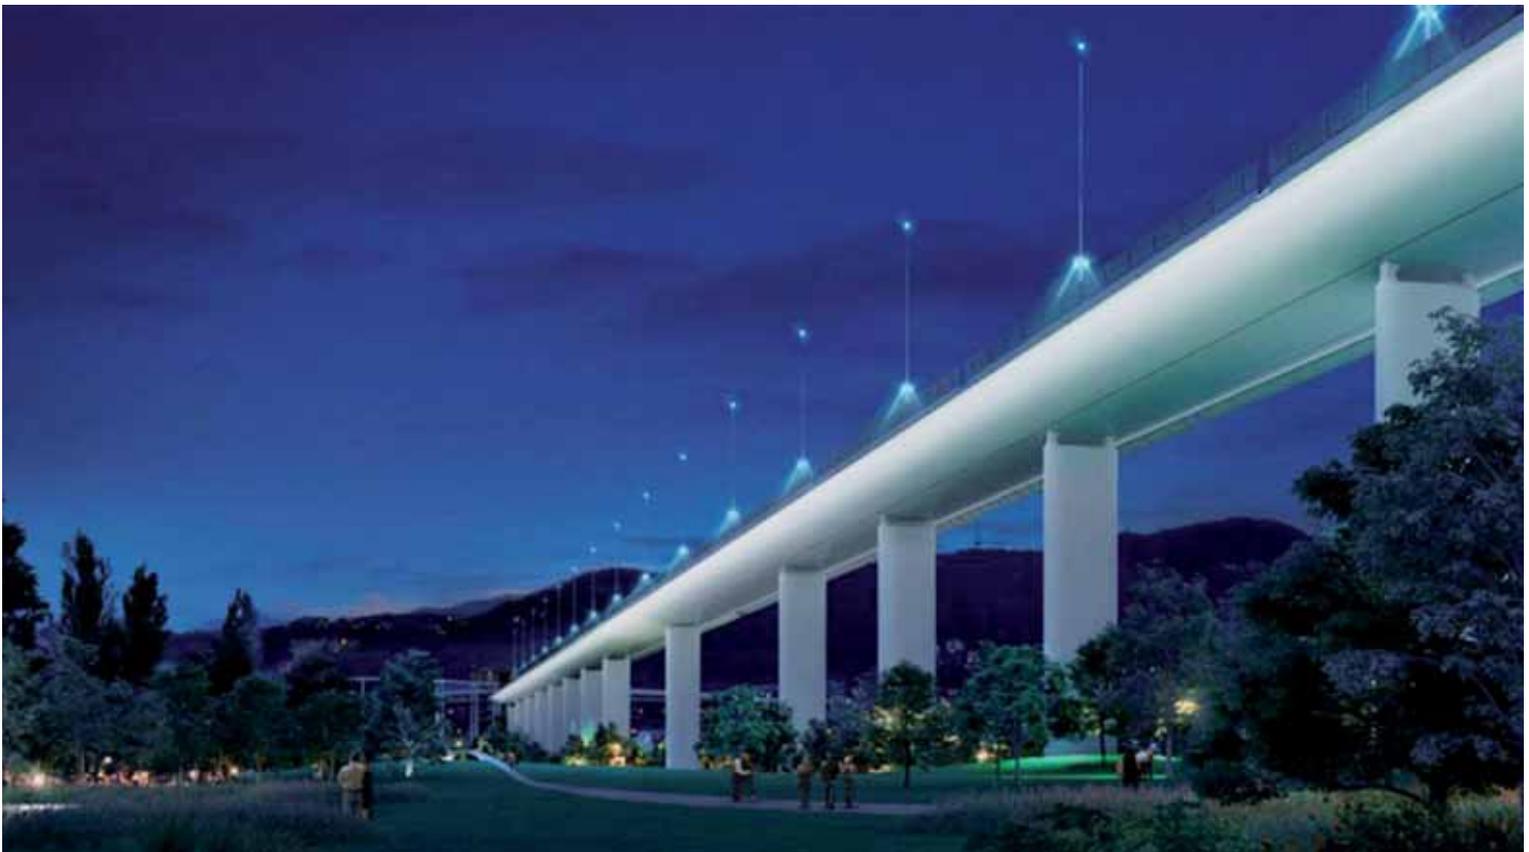
New design Morandi Bridge

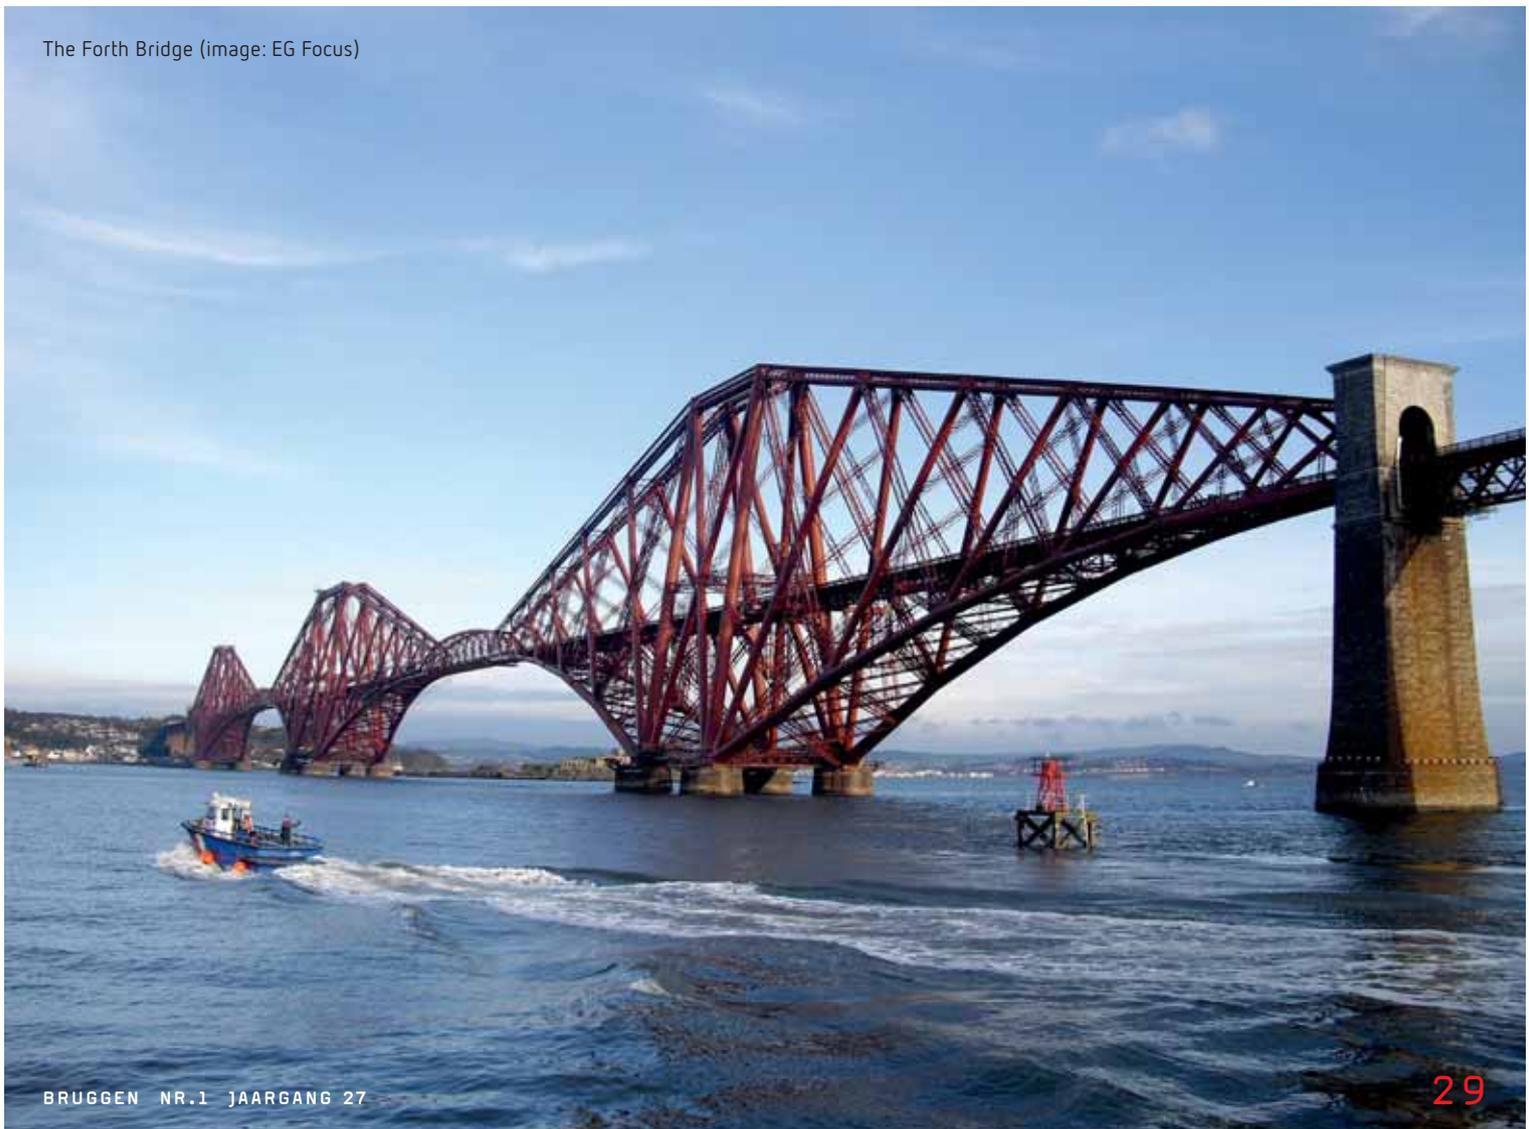
The Forth Bridge (image: EG Focus)

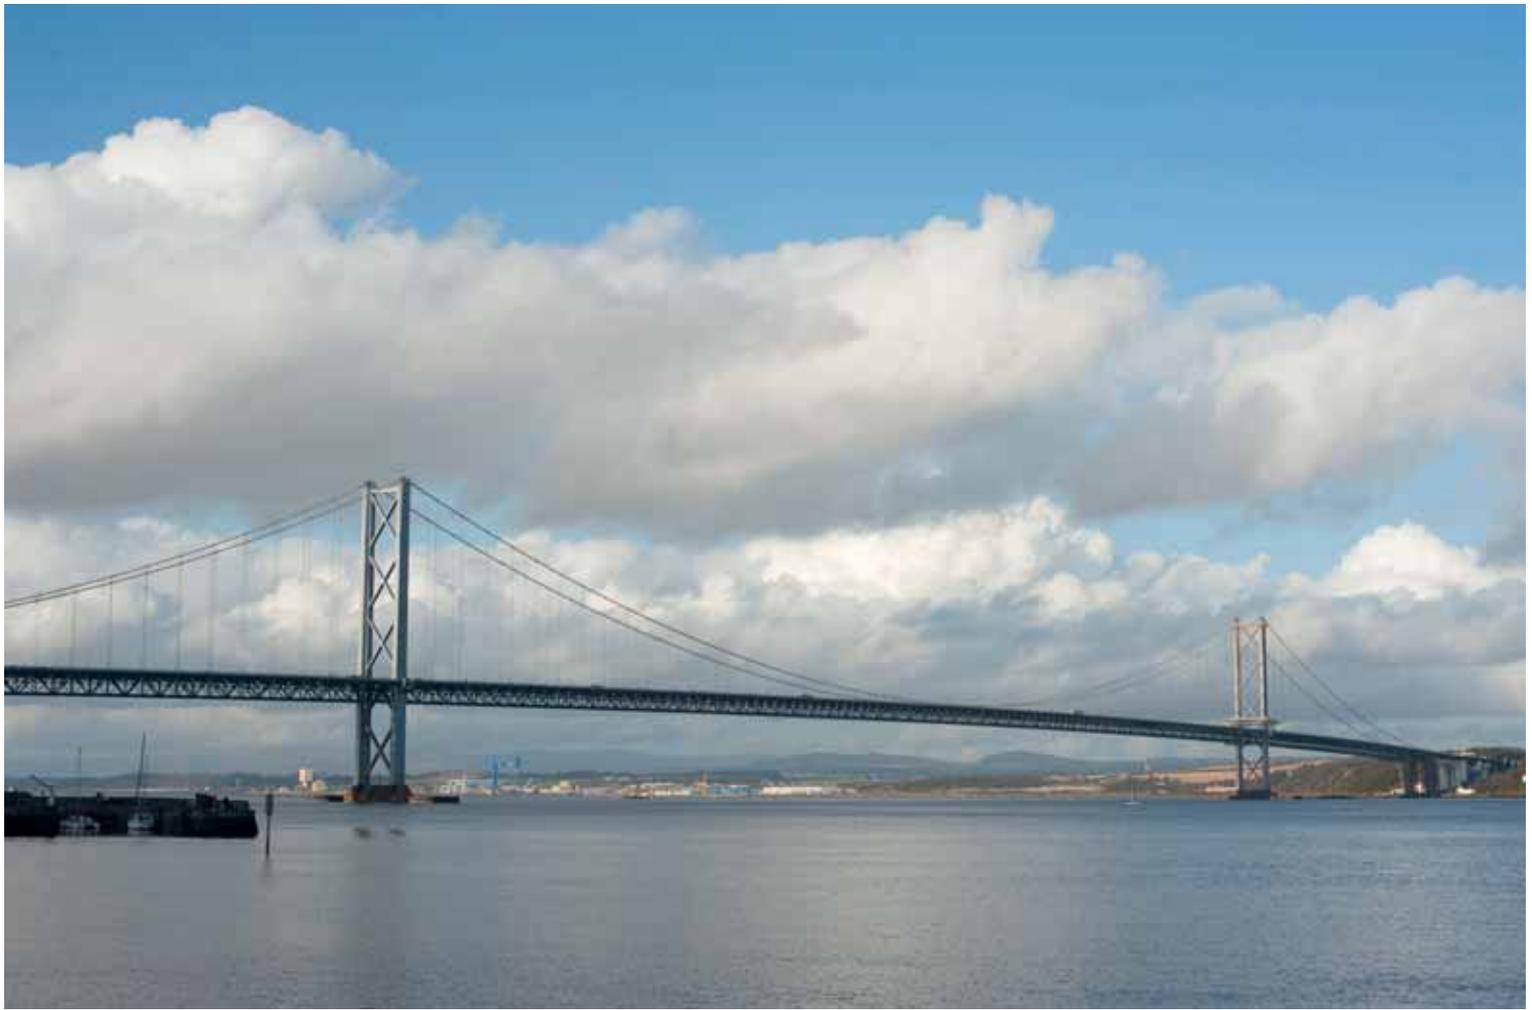
Forth Road Bridge (image: <http://photoeverywhere.co.uk>)

The Forth Road Bridge is a long-span suspension bridge and was opened in 1964. At that time, the bridge had the fourth-longest main span in the world (1006 m). Its deck supports a dual two-lane carriageway and there is a separate footway/cycle track on either side. About 25 million vehicles now cross the bridge each year, more than twice the amount of traffic it was designed for. In contrast to its heavy 19th century neighbour, the Forth Road Bridge presents an efficient lightweight structure.

However aspects of the attitude of ‘build and forget’ was still present during its design, and within less than half of its original design life, the bridge began to show signs of significant deterioration.

One of the major issues to affect the bridge has been corrosion of the main suspension cables. Unfortunately, there is no other way (yet) to inspect the main bridge wires than to

In 2004 the Forth Road Bridge became the first suspension bridge in Europe to have its main cable opened up to check for signs of corrosion. Although the main cable showed no exterior signs of deterioration, the concern was that corrosion might be present inside –

When the interior of the cable was inspected, engineers were surprised to find that 8-10% of the cable’s strength had already been lost as a result of corrosion – despite the cable at that time being just 40 years old.

Based on good experiences in Europe, but also Japan and the USA, the decision was taken to install a dehumidification system on the Forth Road Bridge with the aim of reducing the relative humidity to below 40% where corrosion cannot occur. The drying out process was completed by the end of 2009. The dehumidification has been successful and inspections to date suggest no further loss of

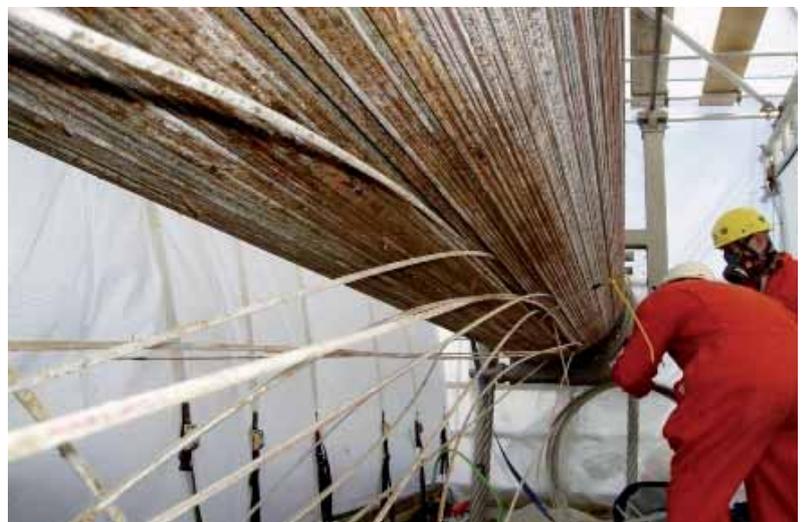
Internal inspection and broken wires (images: Engineer’s Journal - Engineers Ireland)

monitoring system was installed in 2006 in order to monitor future wire breaks within both cables, and to provide information regarding the panels to be opened up for the next internal inspection.

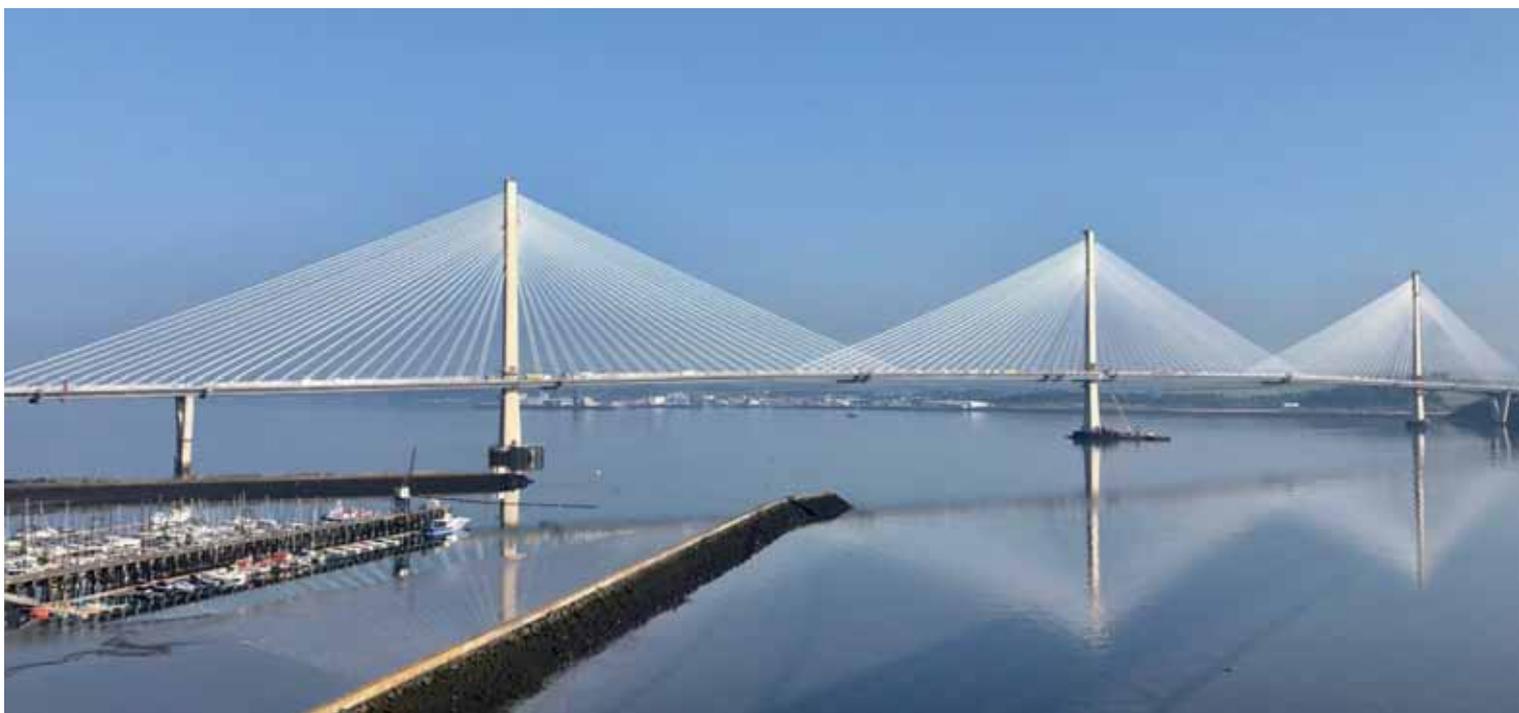
Queensferry Crossing (image: Construction Enquirer)

The bridge presents an evolution in the attitude towards long term maintenance in bridge design. From the outset the design has sought to integrate whole life maintenance, with considerations given to monitoring condition and behaviour and to facilitate the repair and replacement of components if required.

The strands that make up the stay cables can be individually replaced without the need to restrict traffic on the bridge. The bridge has also been equipped with an advanced structural health monitoring system: about 1000 sensors have been installed to monitor the global behaviour of the bridge and its environment in real time (wind, temperature, corrosion, motion and any strains).

This allows the operator to respond quickly to extreme events, to target inspections and to carry out pre-emptive interventions to avoid potential failures.

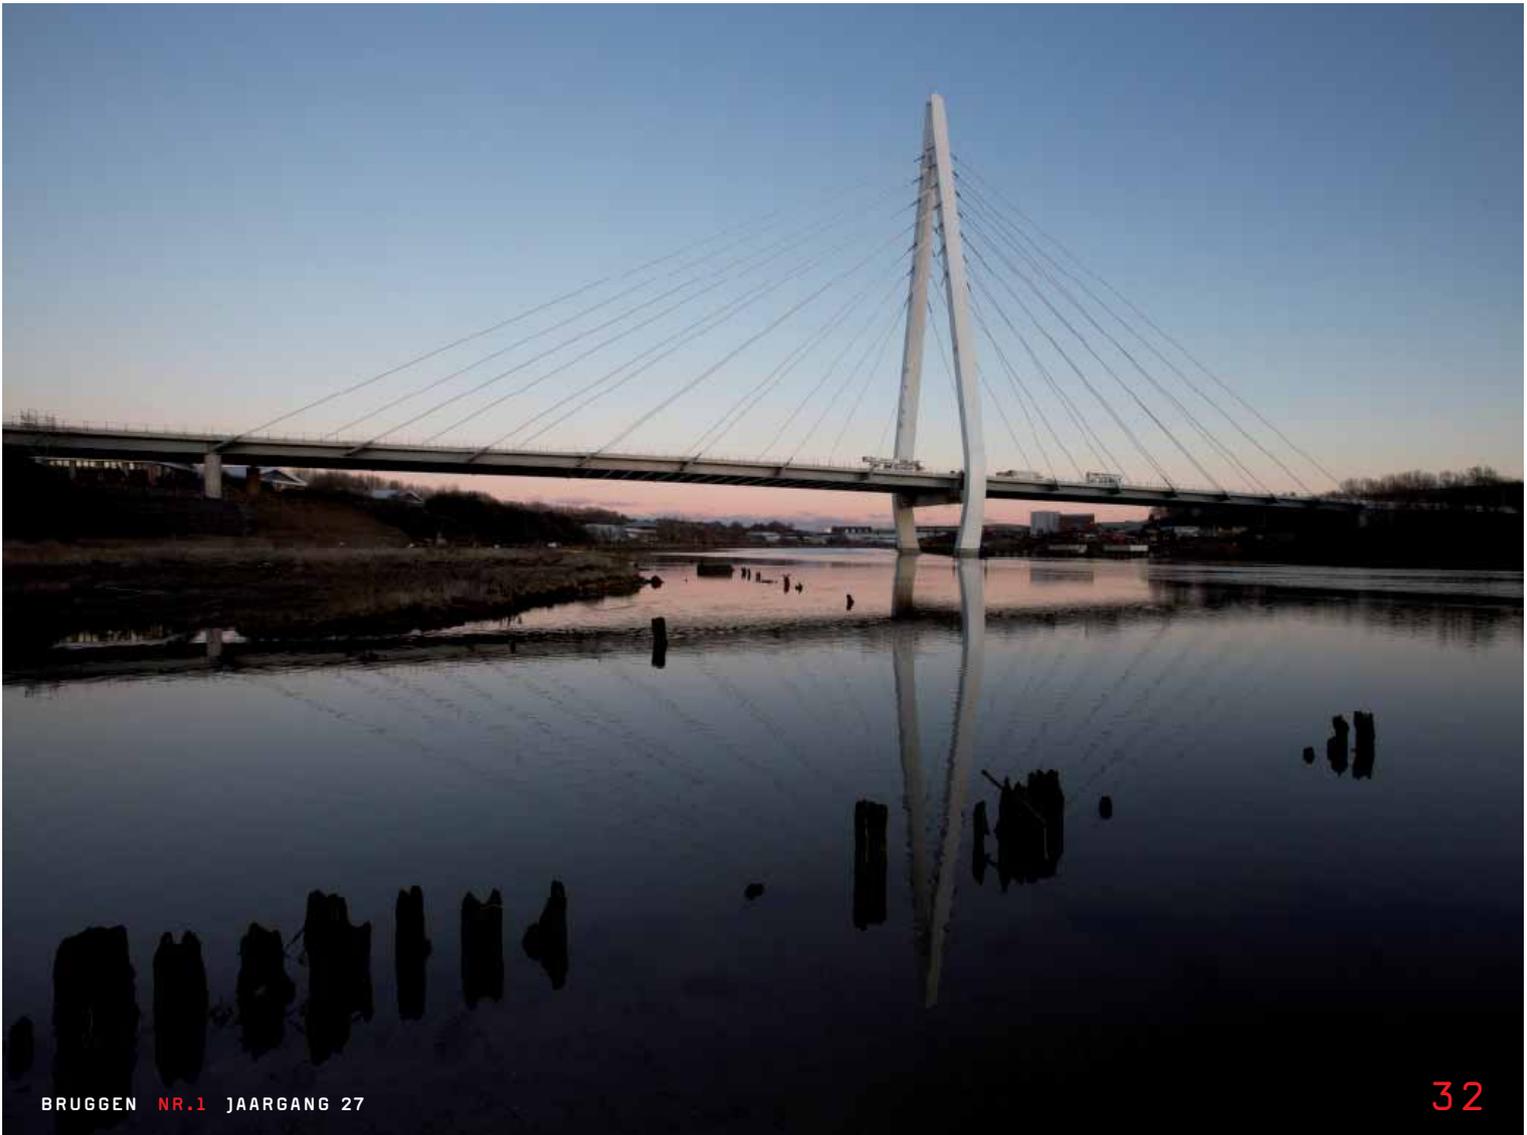
The Northern Spire (image: BuroHappold Engineering)

BuroHappold Engineering designs bridges without disregarding future maintenance. The whole life approach to bridge design is key in each design, including the one for the Northern Spire in Sunderland. Forming a major part of the regeneration of the North East, the Northern Spire - an imposing two span cable-stayed bridge with an A-frame pylon - is the first new road bridge in Sunderland for more than 45 years. Crossing the River Wear, it carries two lanes of traffic in each direction, together with dedicated cycle ways and footpaths, creating a much-needed safe passage for all modes of transport.

- Cable strands individually replaceable.
- Dehumidifying system installed in internal steel pylon.
- Concrete pylon base has high strength concrete specified and the outer layer of reinforcement in stainless steel to minimise the need for future repair works.
- Ends of underdeck electrical service ducts are accessible from abutment galleries. Junction boxes and drawing pits accessible from opening in the bridge deck.
- Additional service ducts provided for possible future services.
- Carefully detailed sub-surface drainage integrated with kerb drainage units.
- Minimisation of number of bearings, including elimination of bearings at pylon location.

- No bearings located over water (nor therefore subject to direct salt water spray).
- Jacking points provided at all bearing locations.
- Added robustness and future-proofing provided by extra load and movement capacity of bearings.
- Highly durable elastomeric expansion joints which do not require replacement.

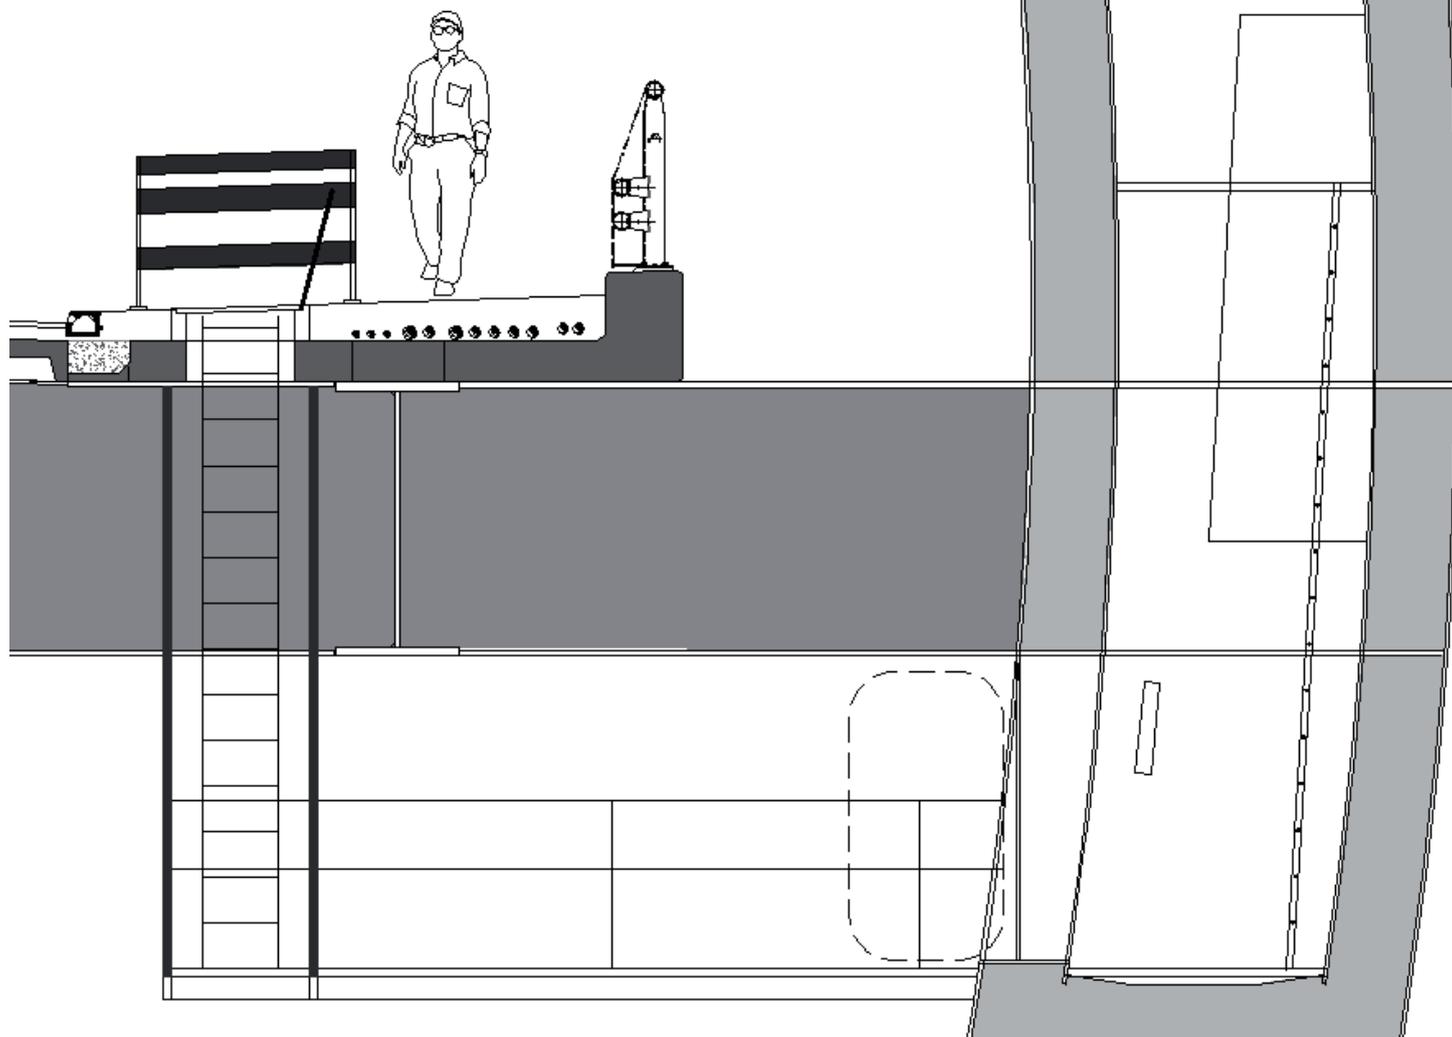
Deck to pylon access (image: BuroHappold Engineering)

The Northern Spire is designed to minimise maintenance requirements and to facilitate ease of maintenance. All elements of the bridge are detailed to cater for future access requirements of a principal inspection. Key areas with regard to access are both the

adjustable and fixed end anchors locations at deck level and within the pylon respectively. The access has been fully integrated into the principle structure. Openings in structural members have been considered in the design and detailing of these along with all fixtures, fittings and clearances required for access. Besides facilitating access for inspection and maintenance, it has also been ensured that all inspection and testing equipment are catered for in the design and in the detailing of the bridge. Platforms, ladders, guardrails, internal lighting and power sources have all been provided. Connection points have been provided on the steel pylon for installation of a proprietary scaffolding system for access to the external pylon. The inner face of the pylon is to be accessed by abseiling. Lessons have been learnt from the past and the below mentioned technical enhancements have been incorporated in the
